AFRL-AFOSR-VA-TR-2016-0144

A New Approach Towards Characterizing Microstructural Influence on Material Behavior Under Very High Cycle

Samantha Daly
UNIVERSITY OF MICHIGAN

09/30/2015
Final Report

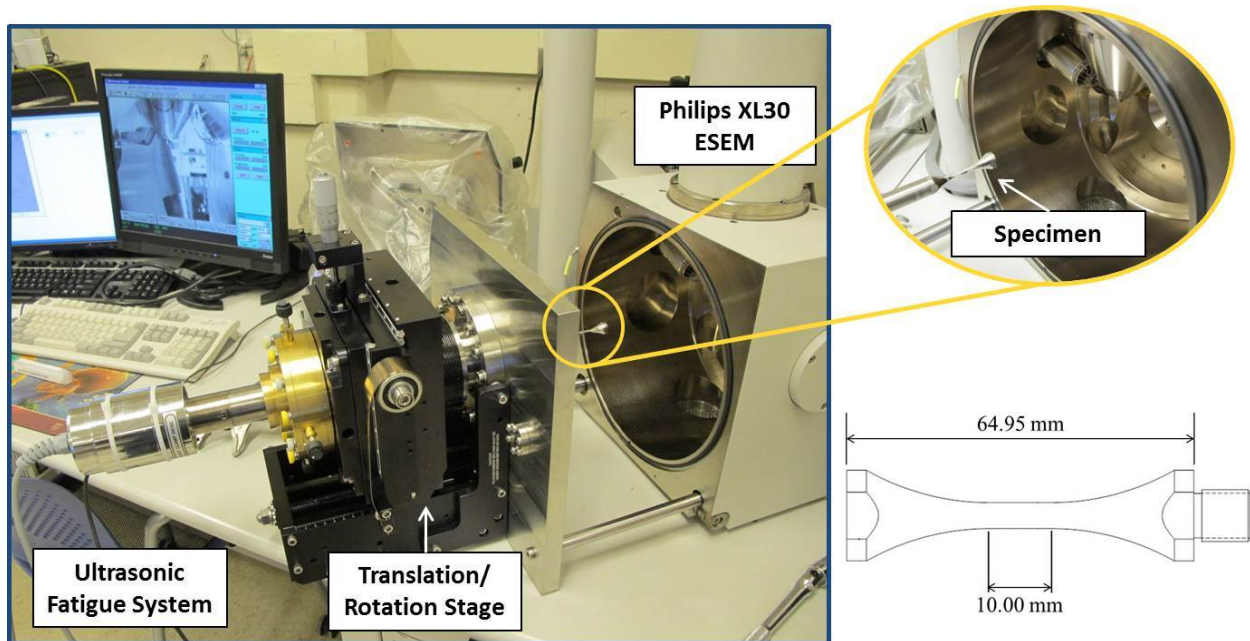
Fig. 1. Ultrasonic fatigue scanning electron microscope (UF-SEM) system combining ultrasonic fatigue at 20 kHz with the high resolution imaging capabilities of a SEM. This system was built in collaboration with C. Torbet, UCSB.

High spatial resolution (≈ 5 nm) imaging of fatigue damage at the microstructural length scale was accomplished using a custom combination of ultrasonic fatigue and scanning electron microscopy, termed UF-SEM and shown in Fig. 1. This system combines ultrasonic fatigue testing instrumentation with a Philips XL30 ESEM. The ultrasonic fatigue instrumentation operates using the principles described in [12] and summarized here. The load line of the system is comprised of Ti-6Al-4V components tuned to a 20 kHz resonant frequency. The components include an ultrasonic converter that imparts a controlled sinusoidal displacement using a piezoelectric material stack, an amplification horn that magnifies the displacement from the ultrasonic converter, a lambda rod, and the fatigue test specimen. The system, which is mounted to a custom built SEM chamber door, is controlled by instrumentation that accurately maintains the resonant frequency within ± 1 Hz in displacement control by monitoring the input displacement to the specimen using a piezoelectric transducer in a closed-loop control system.

Integrating the ultrasonic fatigue instrumentation into an ESEM provides the capability to perform fatigue studies under environmental conditions ranging from vacuum (3.7×10^{-4} Pa) to low partial pressures (133 Pa to 2660 Pa) of selected gases. A gaseous secondary electron (GSE) detector was used for electron imaging in low vacuum and gaseous environments. The fatigue specimen is positioned in the desired imaging orientation using a McAllister Technical Services MB1500 manual manipulator stage with five translational adjustments (including insertion). The

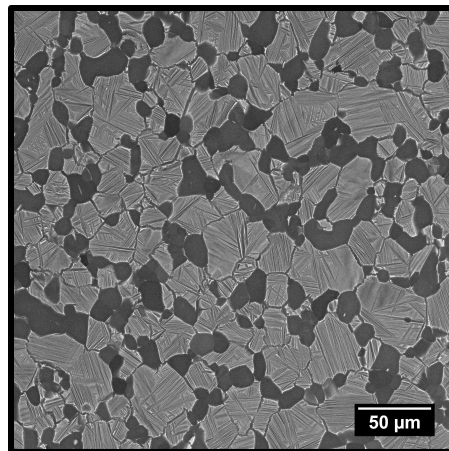
Fig. 2. Back-scattered electron (BSE) micrograph of Ti-6242S microstructure showing primary α grains in a transformed β matrix.

Ti-6242S, a polycrystalline, near-alpha titanium alloy was provided in the form of a forged disc. The alloy was processed to produce a bimodal microstructure and had a nominal composition of wt.%. 6Al, 2Sn, 4Zr, 2Mo, 0.1Si, and Ti (balance). The microstructure consisted of primary α grains in a transformed β matrix, as shown in Fig. 2. The average primary α grain size measured by the linear intercept method was $12.5 \mu\text{m} \pm 5.5 \mu\text{m}$. The area fraction of the primary α phase was approximately $30\% \pm 3\%$. The measured Young's modulus and yield stress were 121 GPa and 926 MPa, respectively.

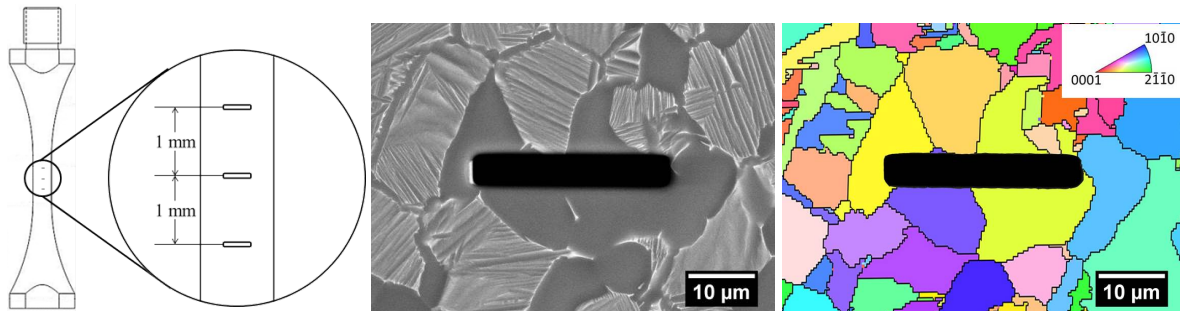
Fig. 3. Schematic of ultrasonic fatigue specimen with surface flats and three FIB micro-notches placed in the center gage section. A BSE image of a FIB micro-notch is shown with the corresponding inverse pole figure (IPF) map of the surrounding microstructure.

To investigate small crack growth behavior, micro-notches were machined in the specimen flats using a FEI Nova Nanolab focused ion beam (FIB) SEM equipped with a gallium ion source operating at 30 kV and a probe current of 3.0 nA. FIB machining processes induce damage by gallium ion implantation that can alter the local mechanical properties. However, previous studies reported the penetration of 30 kV gallium ions to be much less than 1 μm [24]. Furthermore, a reduced probe current of 3.0 nA was used to minimize the depth of gallium ion penetration to less than approximately 200 nm. Three 30 μm long and approximately 15 μm deep FIB micro-notches were machined in the center region of the gauge section of each specimen, with a spacing of 1 mm between notches, as shown schematically in Fig. 3. FIB-

deposited Pt markers were placed in a 200 μm by 100 μm rectangle centered about each FIB micro-notch to enable alignment of the EBSD and fatigue test field of view (FOV). Local microstructural information was determined in these neighborhoods by EBSD.

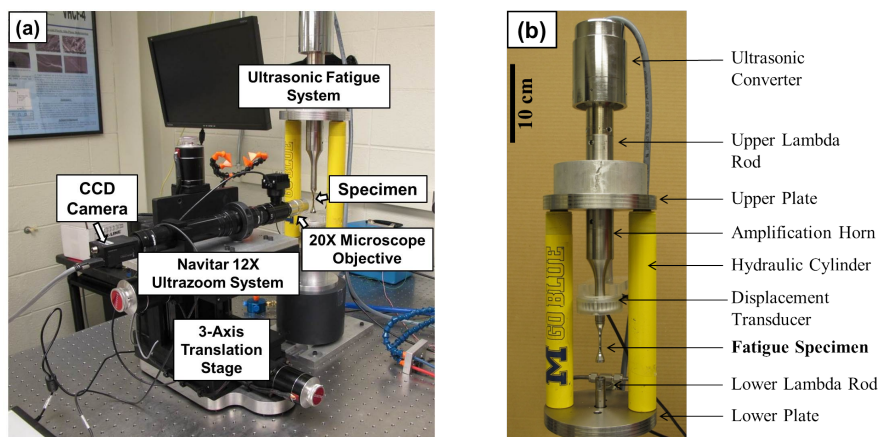
Fig. 4. (a) Laboratory air setup including Navitar 12X Ultrazoom optical system and ultrasonic testing system and (b) a magnified view of the ultrasonic testing system.

Ultrasonic axial fatigue testing was performed in lab air and in the ESEM at a vacuum level of 3.7×10^{-4} Pa. The use of ultrasonic fatigue allowed the attainment of fatigue lifetimes of $>10^7$ cycles in a matter of hours, rather than days as required by conventional methods. Fatigue testing in laboratory air was accomplished using the ultrasonic fatigue instrument described in [16] and shown in Fig. 4. For testing in laboratory air, observations of fatigue crack growth were made using a Navitar 12X Ultrazoom lens system equipped with a 20X Mitutoyo infinity corrected objective and a 5-megapixel CCD (Point Grey GRAS-50S5C). The custom-built UF-SEM system was used for all in-SEM tests. All tests were carried out at a stress ratio of $R = -1$ (fully reversed) and a testing frequency of approximately 20 kHz. For all tests, a constant displacement amplitude was maintained to produce a stress amplitude of 400 MPa.

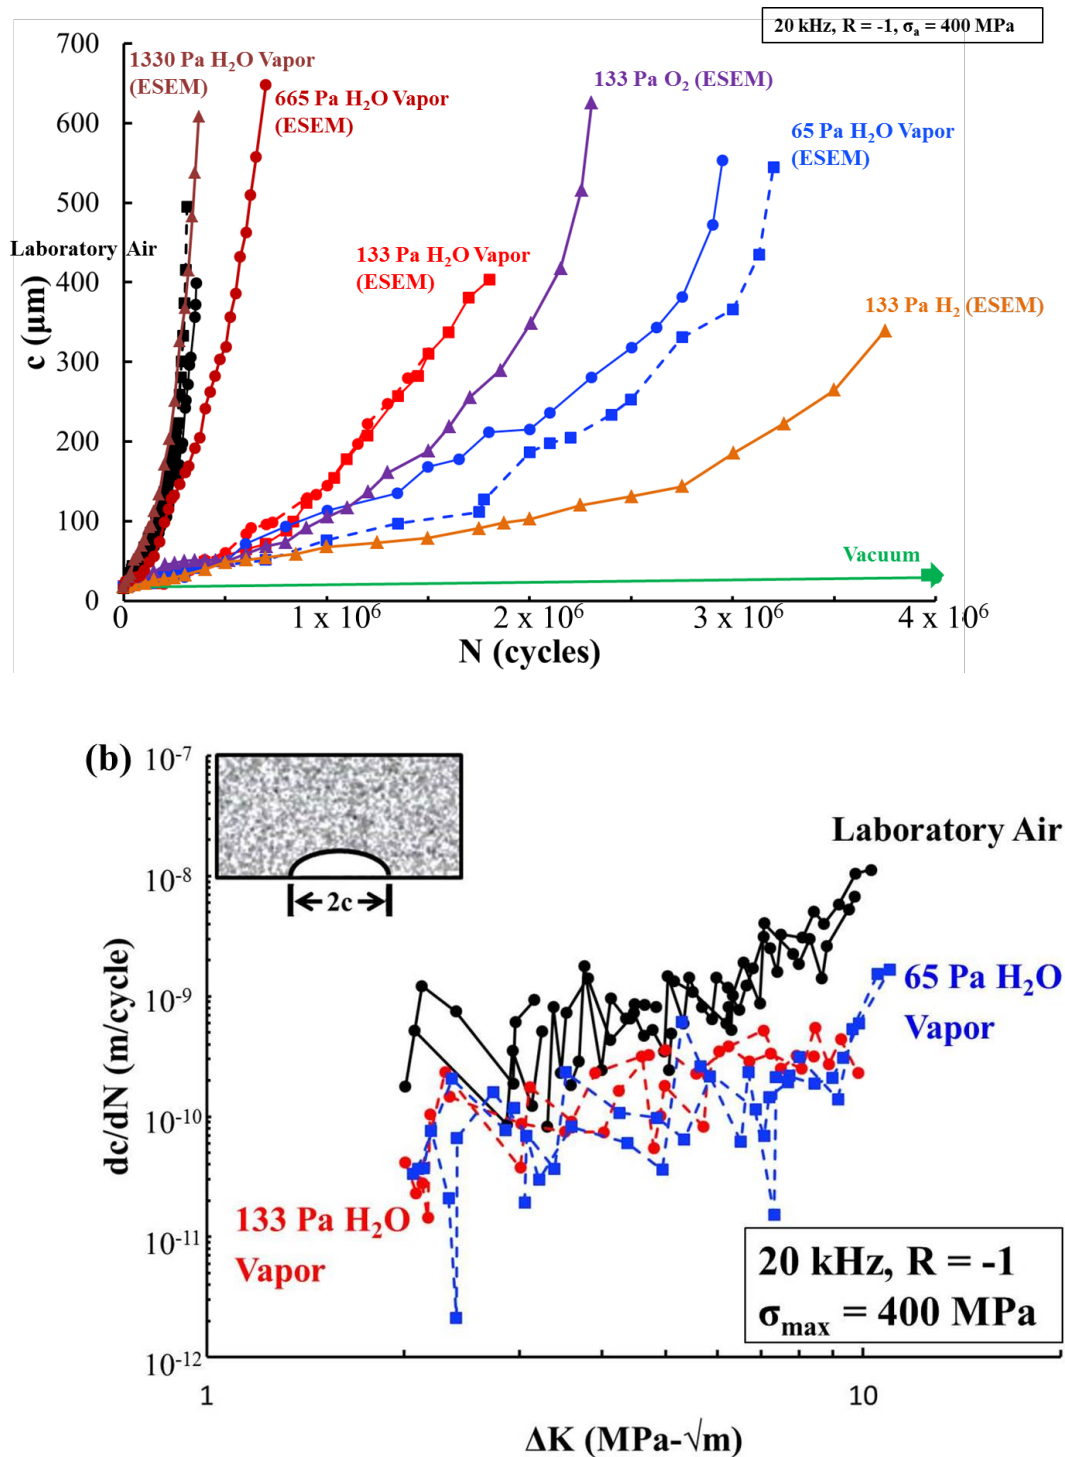
Fig. 5. Fatigue crack growth in laboratory air, high purity hydrogen, high purity oxygen, and water vapor environments. (top) Crack length (c) vs. cycle number (N) is shown. Fatigue

lifetimes were substantially lower in air than in the vapor H₂O vapor environments, with lifetimes uniformly decreasing as vapor pressure increased. Oxygen was the more deleterious species as compared with hydrogen. (bottom) The fatigue crack growth rate (dc/dN) vs. ΔK for three H₂O vapor environments showing a pronounced increase in FCGR for laboratory air versus H₂O vapor environments. Significant dips in the fatigue crack growth rate dc/dN were also found to be correlated to microstructural barriers.

The effects of the environments listed above are shown in Figure 5. For clarity, fatigue crack growth data from non-fatal cracks was omitted from the plots in Fig. 5. However, the data from non-fatal cracks is in agreement with the reported data for the fatal cracks in each test case. Higher H₂O vapor pressures resulted in significantly increased fatigue crack growth rates and reduced fatigue lifetimes. An order of magnitude increase in fatigue life was observed for tests carried out in significantly lower (133 Pa and 65 Pa) H₂O vapor over those carried out in laboratory air. The crack growth rates for 133 Pa H₂O were moderately higher than 65 Pa H₂O. As seen in Fig. 5, fatigue lifetimes were markedly shorter and crack propagation rates were much higher in laboratory air tests than for in-SEM tests. As the H₂O vapor pressure approached 1330 Pa, the crack length (c) vs. cycle number (N) curve approached that of lab air, until the two curves overlaid each other.

Fatigue crack growth under a 3.7×10^{-4} Pa environment (SEM chamber vacuum) was also examined as shown in Figure 5. Small fatigue crack growth rates were lowest in the vacuum environment (3.7×10^{-4} Pa). In all vacuum experiments, the crack initiated well after 10^6 cycles and propagated for a small distance before crack arrest. After the crack had arrested for a minimum of 10^7 cycles, the stress amplitude was increased in 10% increments until crack growth resumed. The results of a vacuum experiment shown in Fig. 5(a) are from a test in which an approximately 12 μm long crack was observed at 4×10^6 cycles, where $\sigma_{\text{max}} = 400$ MPa. Further cycling of the specimen to 10^7 cycles resulted in a small increase in crack advance ($< 2 \mu\text{m}$). Growing fatigue cracks in vacuum using the same stress amplitudes used for environmental tests proved challenging because of their low growth rate. Due to time and cost restraints, in the present work vacuum tests were either step tested to much higher stress amplitudes to cause fatigue failure (up to 700 MPa), or water vapor was introduced to accelerate crack growth.

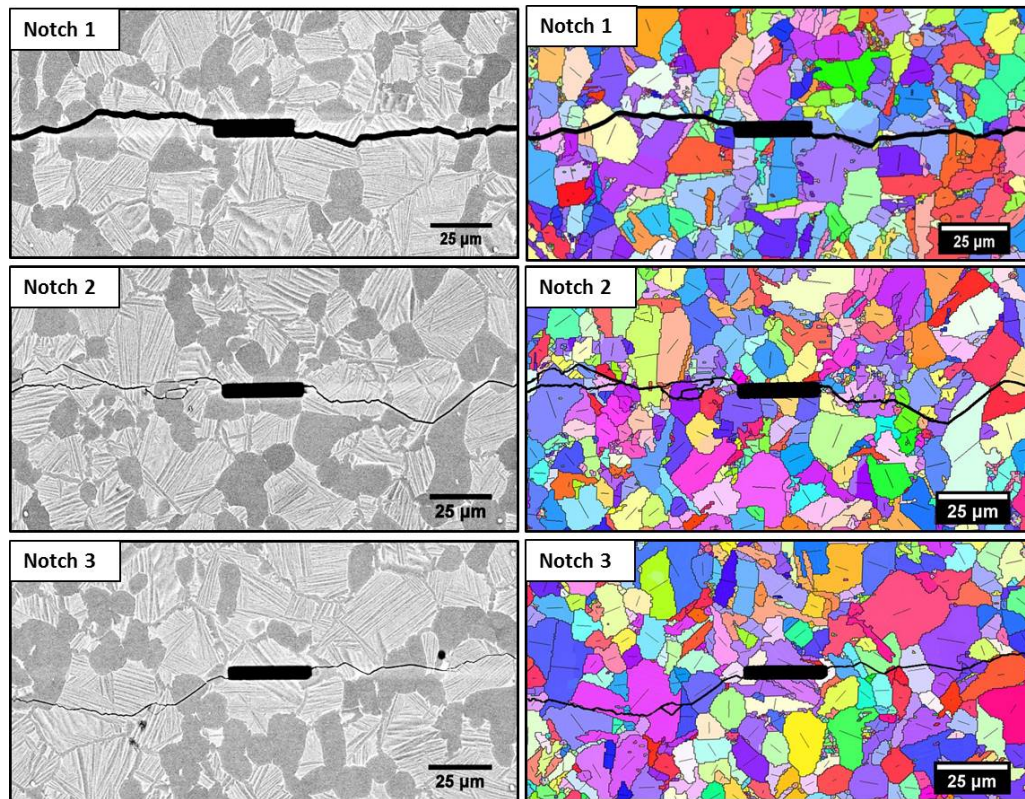
Fig. 6. Small fatigue cracks propagated in a 133 Pa saturated H₂O vapor environment from three FIB micro-notches machined into the same test specimen. The specimen failed at a fatal crack that was initiated and grown from Notch 1. Transgranular, crystallographic crack growth was observed in each case.

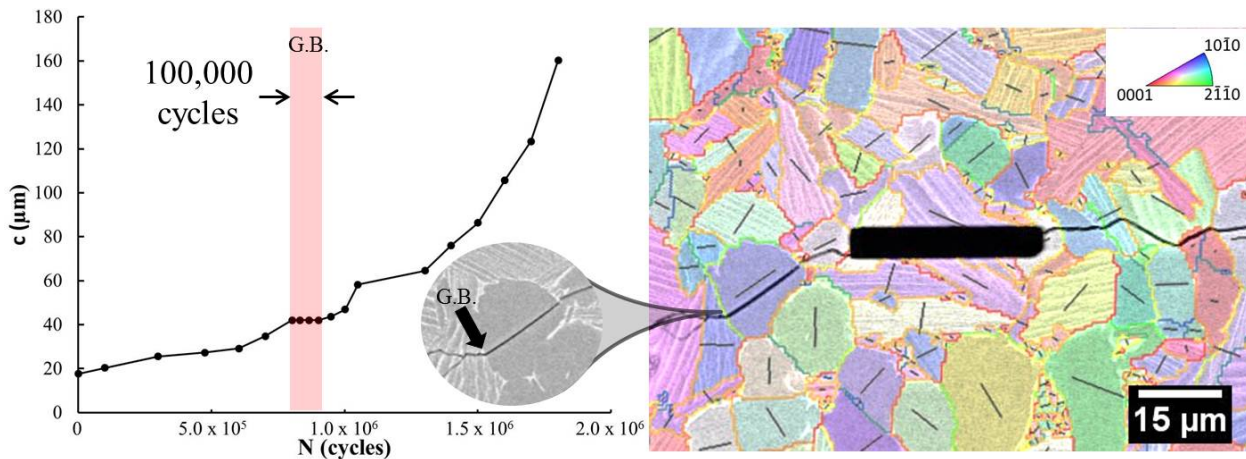
Fig. 8. A small fatigue crack was initiated and grown in 133 Pa H_2O vapor. A micrograph of the local microstructure surrounding the notch and the propagated crack with the IPF map overlaid is shown. The black lines denote basal plane traces. The left side fatigue crack propagated along basal planes in α grains and arrested at the $\alpha/\alpha+\beta$ phase boundary indicated by the arrow for approximately 10^5 cycles.

Significant local variability in the small fatigue crack growth rate was observed in each environment, and was frequently correlated with microstructural features such as high misorientation angle grain boundaries and phase boundaries. Fig. 7 shows a fatigue crack that propagated in laboratory air along basal planes in two neighboring primary α grains for 3.0×10^4 cycles before arresting for the duration of the test (3.1×10^5 cycles) at an α/α grain boundary with a misorientation of approximately 80° . Fig. 8 shows a fatigue crack grown in 133 Pa H_2O vapor that arrested for approximately 10^5 cycles at an $\alpha/\alpha+\beta$ phase boundary. The misorientation angle between these two grains was low and likely not responsible for the reduction in crack growth rate observed at this boundary. Rather, this reduction could be an effect of the crack crossing from a primary α grain to a transformed β phase region, as lamellar regions have a higher fatigue crack growth resistance [35]. Crack arrest at the grain boundary may also have been affected by the low basal Schmid factor of the transformed β region, as grains that are unfavorably oriented for basal slip have been observed to impede crack growth in titanium alloys [34].

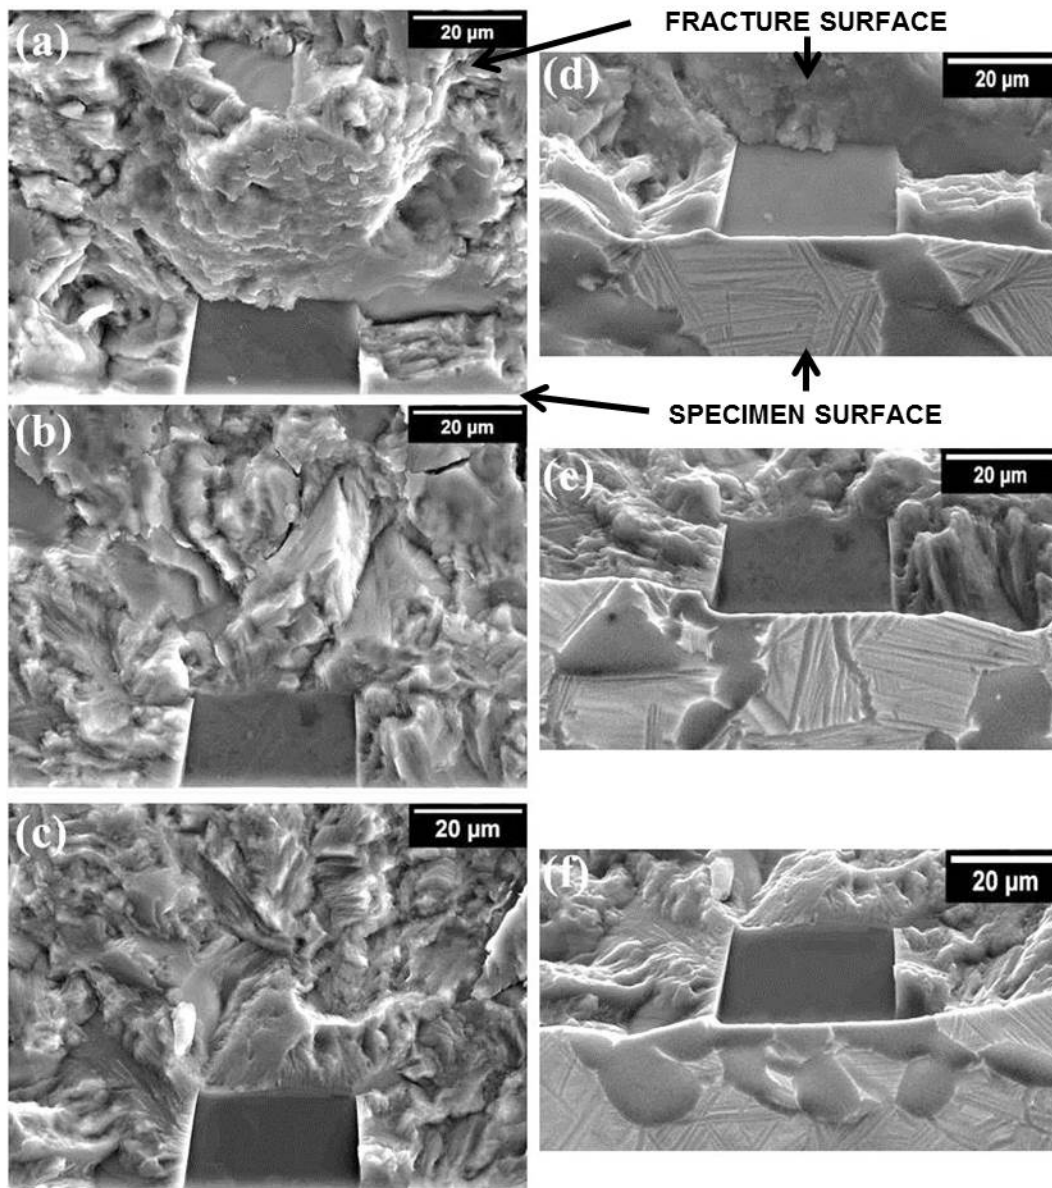
Fracture surfaces of fatal cracks for (a) laboratory air, (b) 133 Pa H₂O vapor, and (c) 65 Pa H₂O vapor. The images on the left show the specimen fracture surface as viewed along the loading direction. The images on the right show the corresponding fracture surfaces on the left with a BSE image of the adjacent surface microstructure as viewed by a 45° tilt with respect to the loading direction.. Facetted fracturing is observed in each of the test environments in the early stage crack growth region.

In both the 133 Pa H_2O vapor and 65 Pa H_2O vapor environments, fatigue cracks propagated transgranularly and were microstructurally sensitive in the low ΔK regime. Observed fracture surface features for the two low vacuum water vapor environments were similar, consistent with the moderate difference in fatigue crack growth rate. Example fractographs obtained in the early crack growth region for each environment are shown in Fig. 9. Macroscopically smooth faceted crack growth across primary α grains was observed for $\Delta K < 7.0 \text{ MPa}\sqrt{\text{m}}$, as shown in Fig. 10. Correlation of primary α grain facets with the adjacent surface EBSD maps showed that faceting predominantly occurred along basal planes. Higher magnification imaging of faceted surfaces revealed crack growth markings, or bands, indicative of a slowly advancing crack, rather than a cleavage-like fracture mechanism. The frequency of primary α facets decreased with increasing crack length. This is attributed to an increase in the crack-tip stress intensity as the crack gets longer and thus, an increase in plastic deformation at the crack-tip.

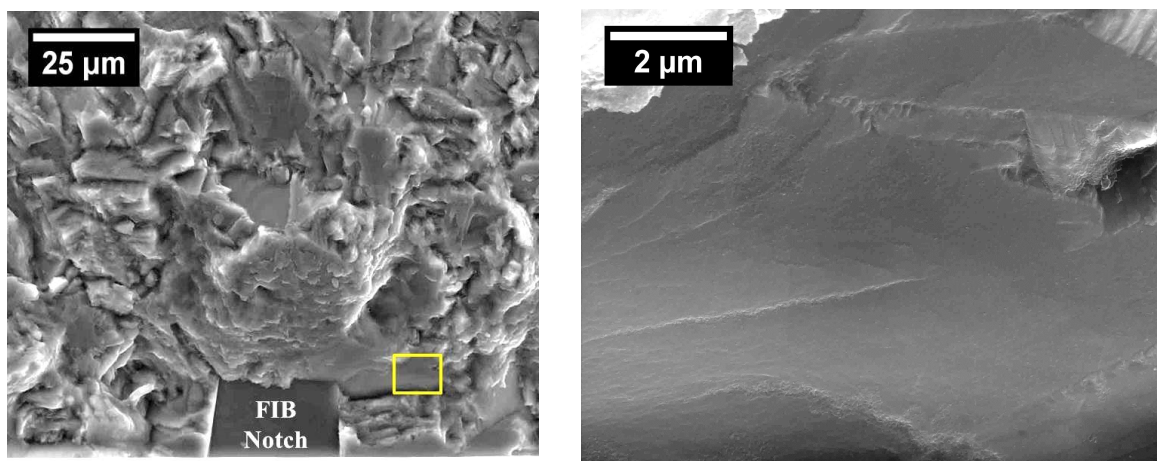
Fig. 11. SEM micrographs of the fracture surface of a fatal crack propagated in laboratory air. At right is a high magnification micrograph of the area in the yellow box in the left image, and shows a macroscopically smooth primary α facet with no striation-like features. The crack propagation direction is from bottom to top ($dc/dN \approx 6.2 \times 10^{-10}$ m/cycle).

Crystallographic, microstructurally sensitive fatigue crack growth was also observed in laboratory air. The fracture surfaces of fatal cracks propagated in laboratory air showed primary α grain faceting during early crack growth. EBSD maps of fractured primary α grains that intersected the specimen surface indicated that low ΔK crack advance took place mainly along basal planes, but likely took fewer numbers of cycles for facet formation. Higher magnification micrographs of macroscopically smooth faceted surfaces showed little to no striation-like markings (Fig. 11), in contrast with the features shown on a faceted primary α grain in Fig. 10. This was in agreement with the observed increase in fatigue crack growth rate in laboratory air versus vacuum environments, where a faster fracture in laboratory air produced fewer fatigue markings on faceted planes. Some facets with coarse band-like features were also observed in the laboratory air experiments, but not in the saturated water vapor and vacuum environments at equivalent crack lengths.

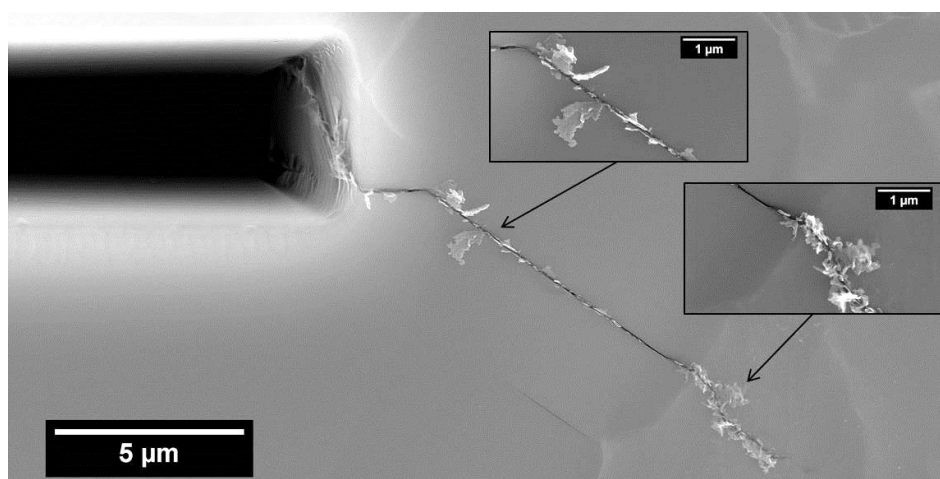
Fig. 12. SEM micrograph of extruded material from a surface crack of a specimen fatigued in vacuum (3.7×10^{-4} Pa). The extruded material transitions from a thin feather-like structure in the primary alpha grain to a globular extrusion upon entering the adjacent lamellar region.

Interestingly, a thin material appears to have been ejected from the crack faces and is still adhered to the specimen surface, as shown in Fig. 12. This phenomenon was observed in numerous tests and depended on microstructure and environment. The test shown in Fig. 12 was conducted in vacuum, and exhibits a transition from a feather-like extrusion in a primary α grain to a more globular morphology in the adjacent transformed β region. The frequency and intensity of the observed extruded material was greater in fatigue tests conducted in vacuum and partial pressures of water vapor than laboratory air. However, note that the specimens tested in

laboratory air were subjected to high velocity air jets, which may have removed extruded material. Sugano et al. [31] observed a similar feature on the specimen surface of a titanium alloy in vacuum fatigue tests at a pressure of 6.7×10^{-3} Pa, $R = -1$, and 10^8 cycles. The detected ribbon-like extrusions occurred at slip bands on the specimen surface. They also observed a decrease in intensity and fraction of these extrusions in specimens fatigued in laboratory air versus vacuum. The mechanism for the creation of these features is likely related to crack closure effects and oxide layer formation. More analysis is underway to determine the composition of these formations and the mechanism by which they are created.
